**Site 12 Field Work Update
Westside/ Bayside/ North Point**

**NAVAL STATION TREASURE ISLAND
SAN FRANCISCO, CALIFORNIA**

**BCT Meeting
October 21, 2015**

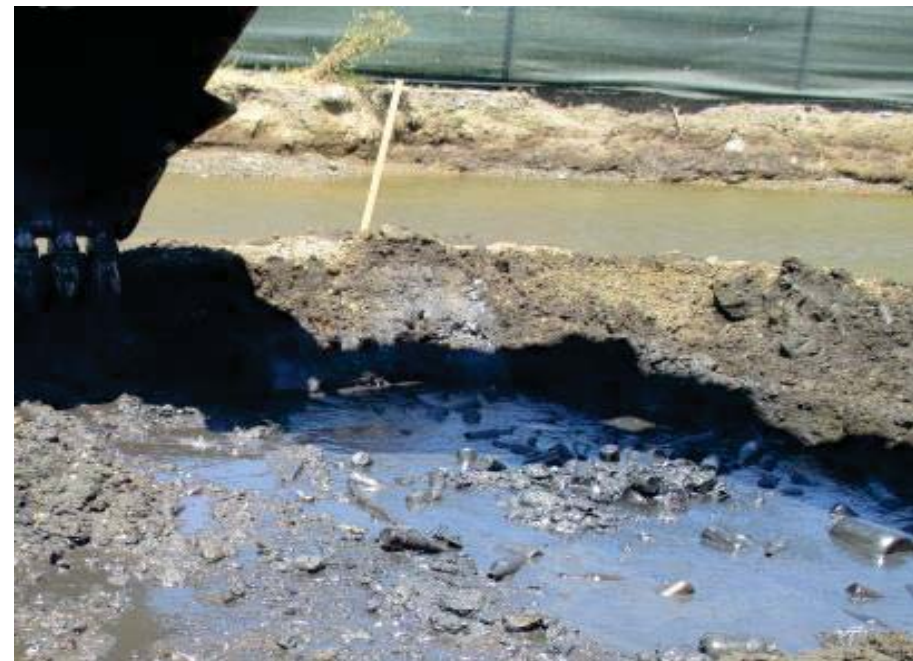
- “Historical Burn Area” documented in area of Building 1207 and 1209 (HRA-STM)
- Darker, burned material. Containing glass, construction debris, and Rad objects
- Munitions scrap was also discovered in burned material

Debris found in Burn Area,

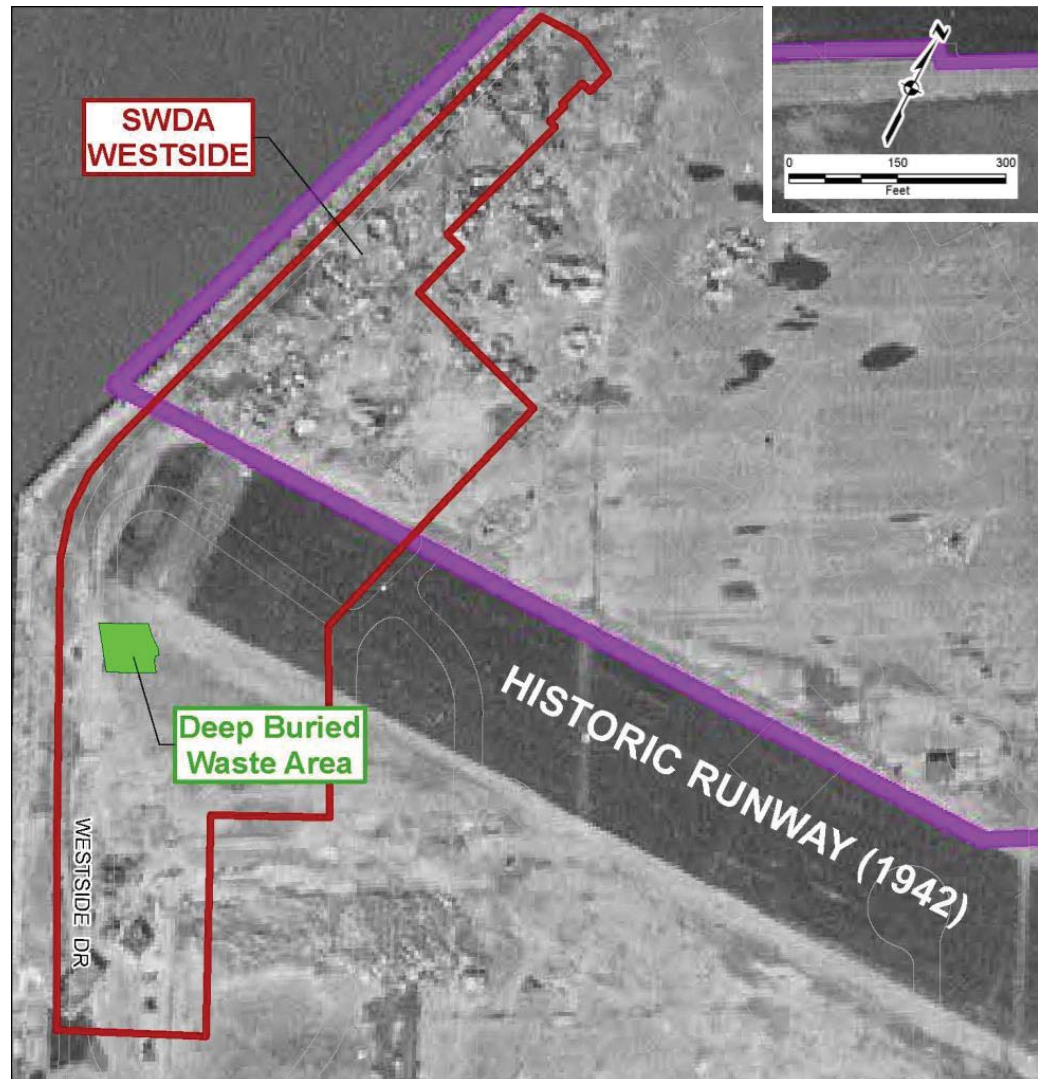
Aerial view of historical runway and Deep Buried Waste Area

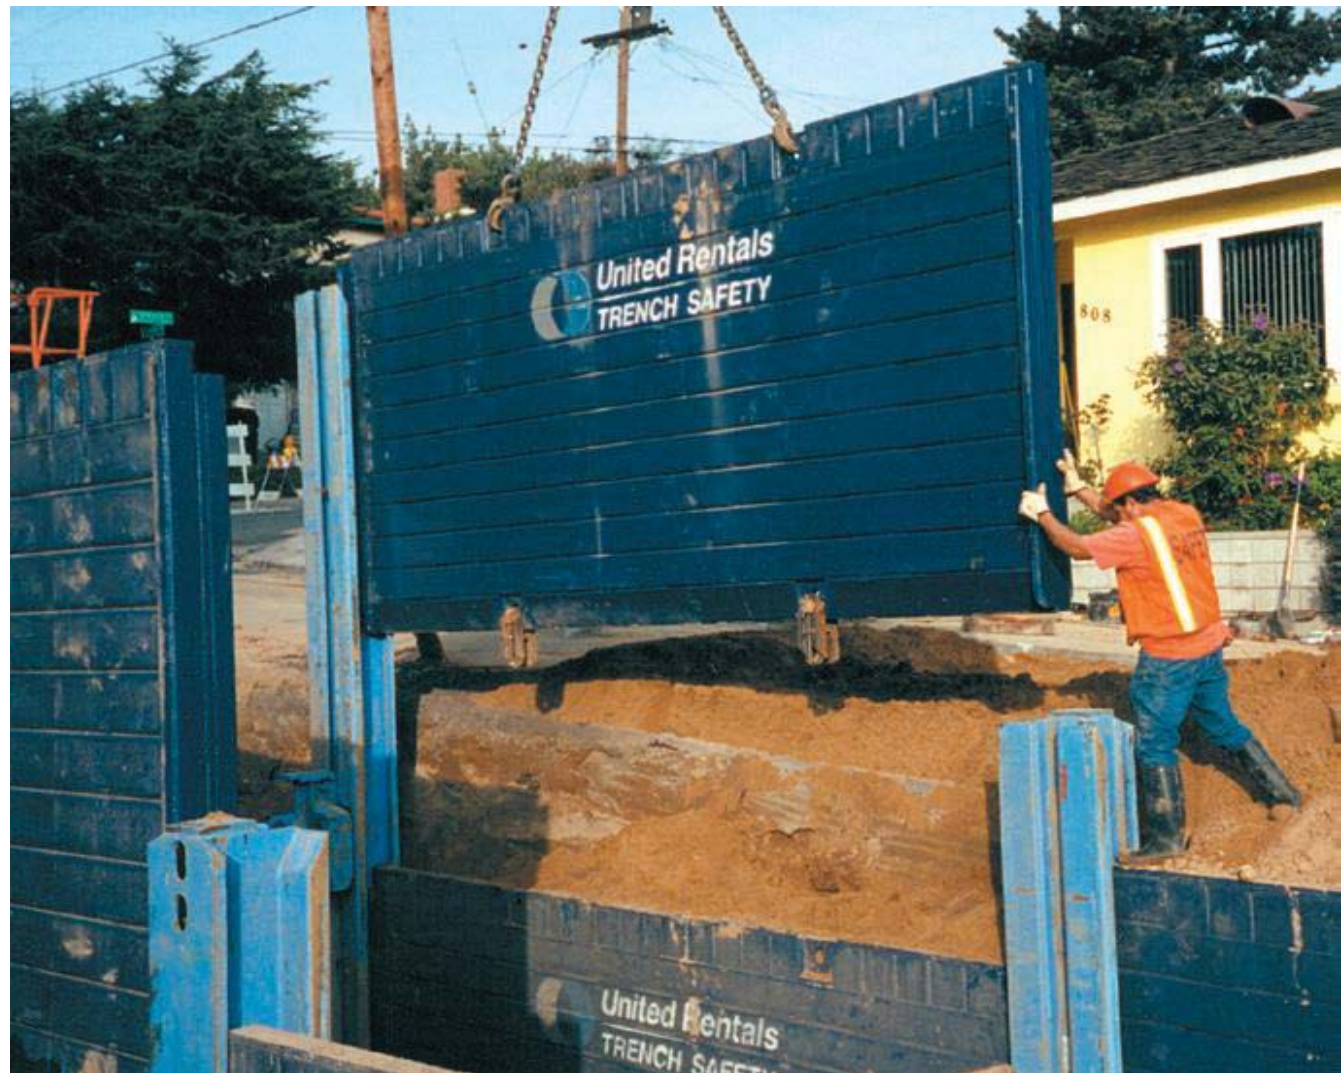
- Historical deep buried waste site located at the end of a former runway
- Located at north east corner of the Building 1321 footprint
- Approximately 60' x 60' square to 10 foot depth
- A slide rail shoring system will be used to protect sidewalls from collapsing

Example of Slide Rail System during installation

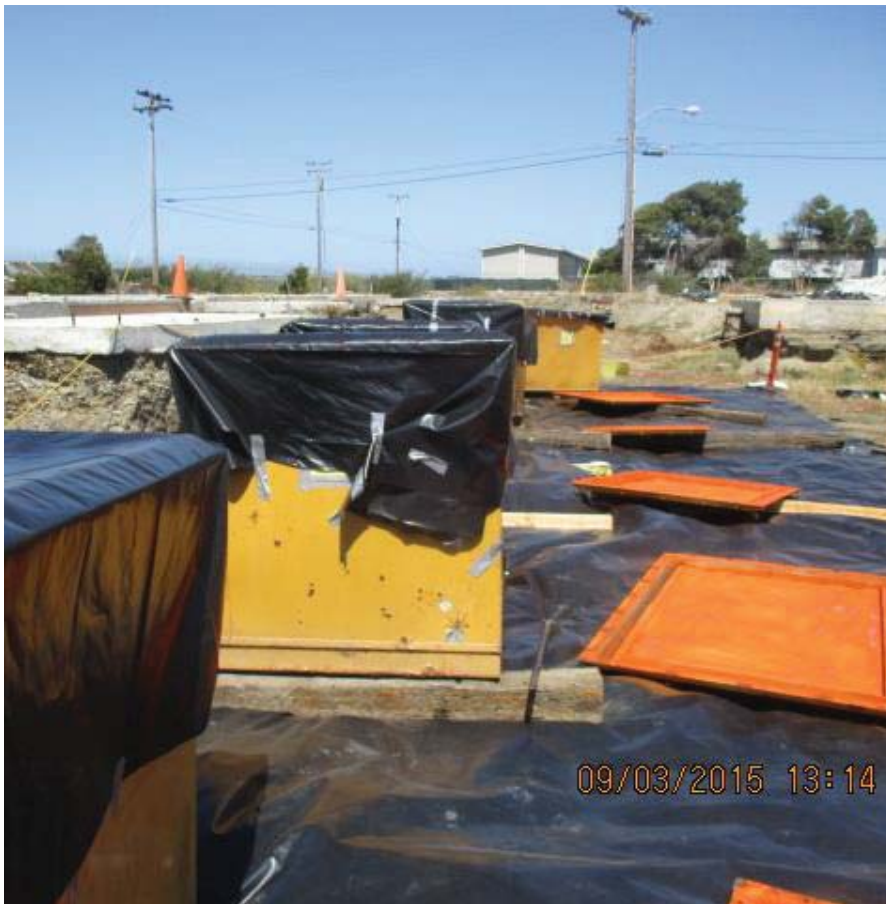
Radiological waste storage containers prepared for sorting

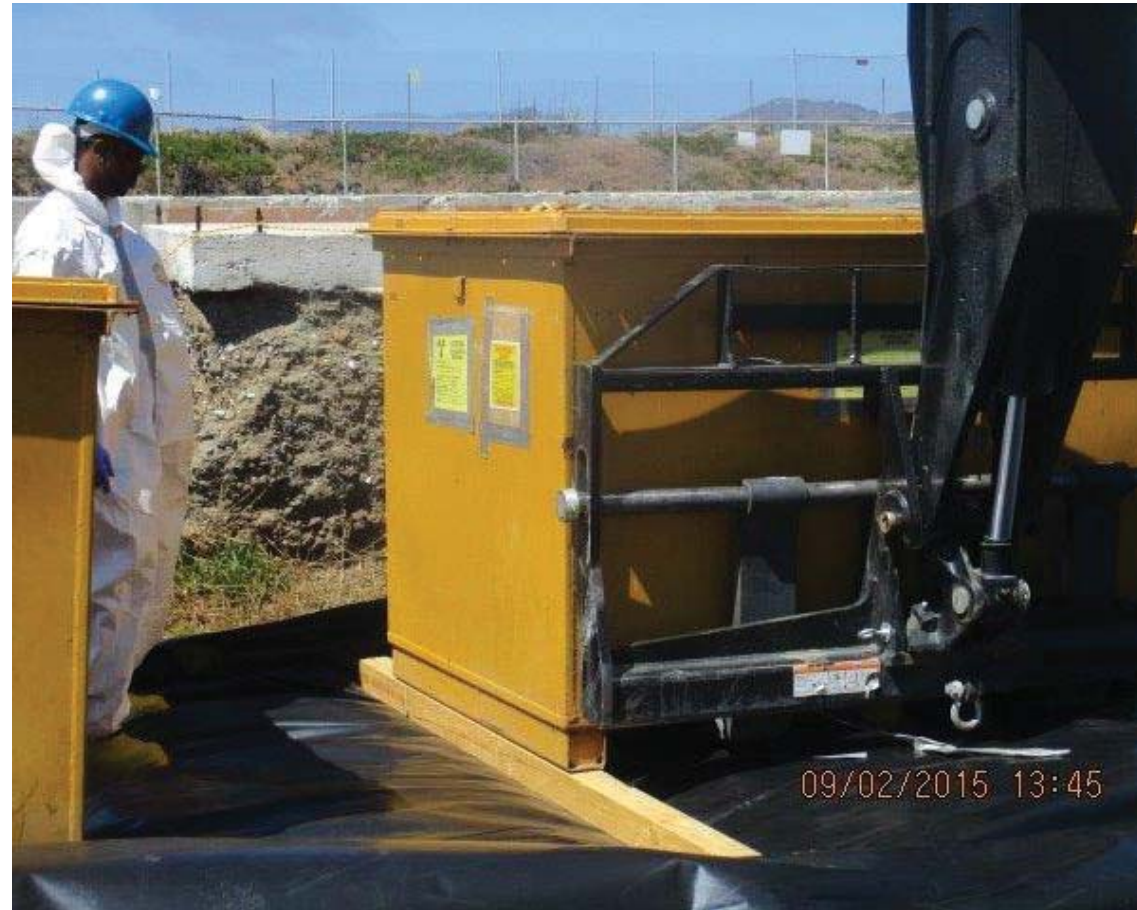
Moving radiological waste storage containers using a fork lift
Into the screening/sorting tent

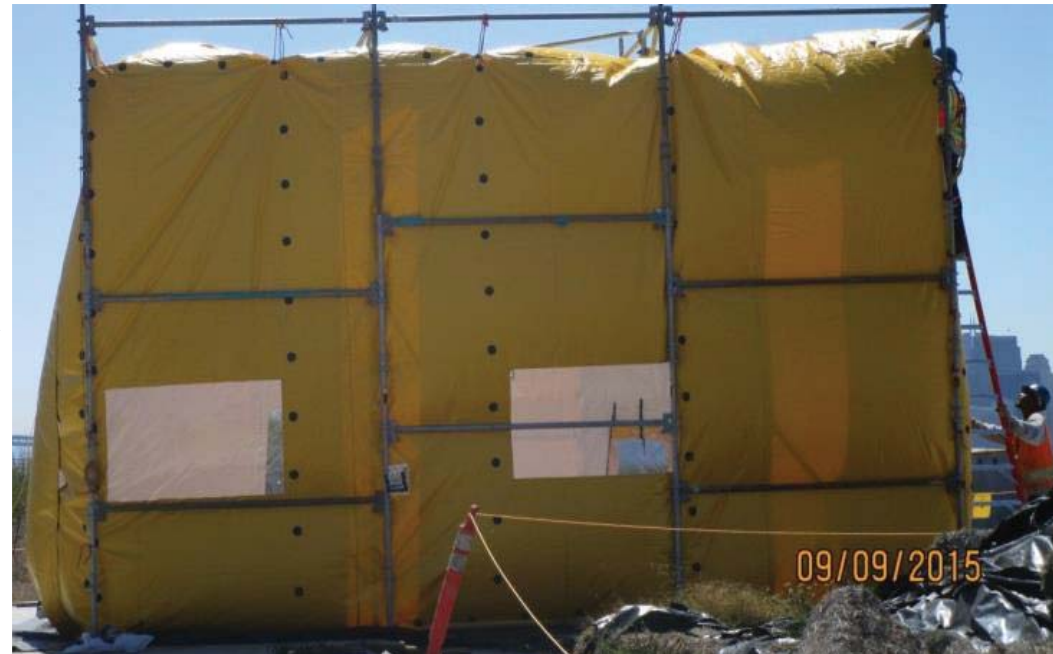
- Work conducted inside sorting tent
- Sorting tent ensures that all material being sorted is contained
- Material within each container is being dewatered, sorted, and repackaged for disposal
- Material is visually inspected by munitions experts
- Munitions scrap is separated from rest of material
- Radiological technicians sort rad objects
- Radiological technicians will survey the storage containers and tent after completion

Sorting/Screening Tent
